# Manhole Inspection Summary

Manhole # S39S\_\_004MH

Insp Date: **3/13/08 9:52 AM**

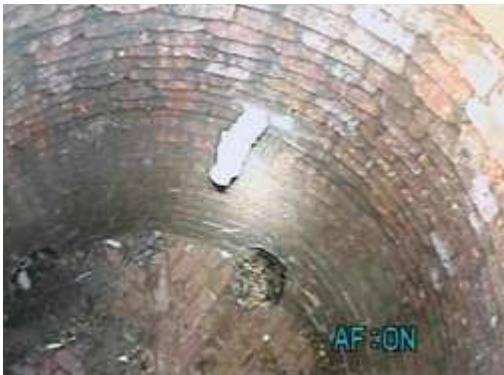
Miscellaneous

water valve, channel debris

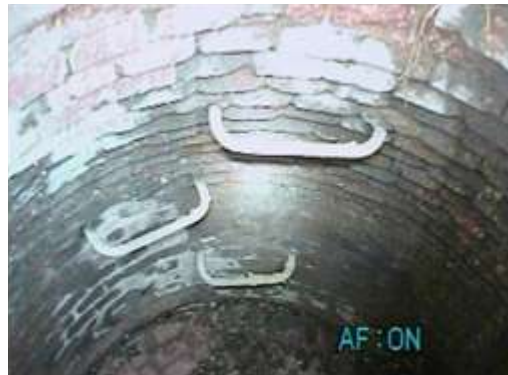
Defect 1

**Steps** Count: **3** Missing: **0** ☒ **Corroded**

steps

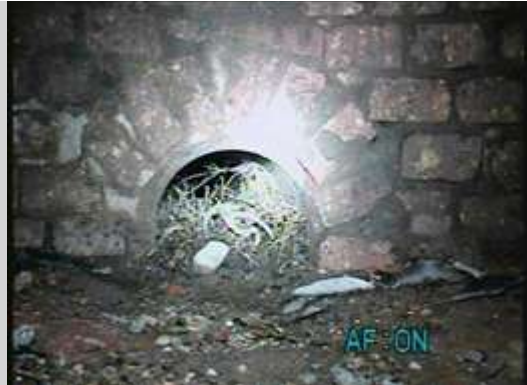
12 O'Clock Outflow

8 in. Circular Gravity Sewer  
Pipe Out @ 12 O'Clock

Deposits: ☐ None ☐ **Mud** ☐ Sludge ☒ **Debris** ☐ Grease

Silt Depth: 6 (in.) Deposits Extent: **Heavy**

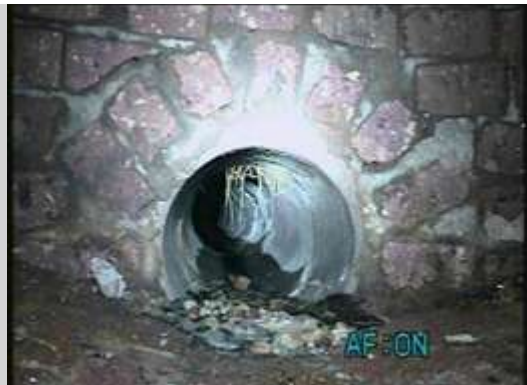
3 O'Clock Outflow

8 in. Circular Gravity Sewer  
Pipe in @ 3 O'Clock

Deposits: ☐ None ☒ **Mud** ☐ Sludge ☐ Debris ☐ Grease

Silt Depth: 1 (in.) Deposits Extent: **Light**
